# Inspection report

Date: <b>05/06/2009</b>	Job N°: <b>T 6323</b>	Weather: <b>No rain or snow</b>	Operator: <b>Dan</b>	section number: <b>1</b>	PLR: <b>FW01 X</b>
Video Volume No.: <b>Vid 001</b>	Flow Ctrl: <b>No flow control</b>	Temperature: <b>above freezing</b>	Year laid:	Cleaned: <b>No</b>	Strat. Drain:

Road: <b>The Hill Avenue</b>	Div/Dist:	start MH: <b>FW01</b>
Place: <b>Number 12</b>	Drain. Area:	end MH: <b>Offsite</b>
Location:	Standard: <b>BS EN 13508-2:2003</b>	Total length: <b>28.8 m</b>

Purpose: <b>Post inspection of repairs or renovations</b>	Shape/Size: <b>Circular 100mm</b>
Type: <b>Gravity drain/sewer</b>	Material: <b>Vitrified clay (i.e. all clayware)</b> Pipe length: <b>0.7m</b>
Use: <b>Foul</b>	Lining: Lining Type:

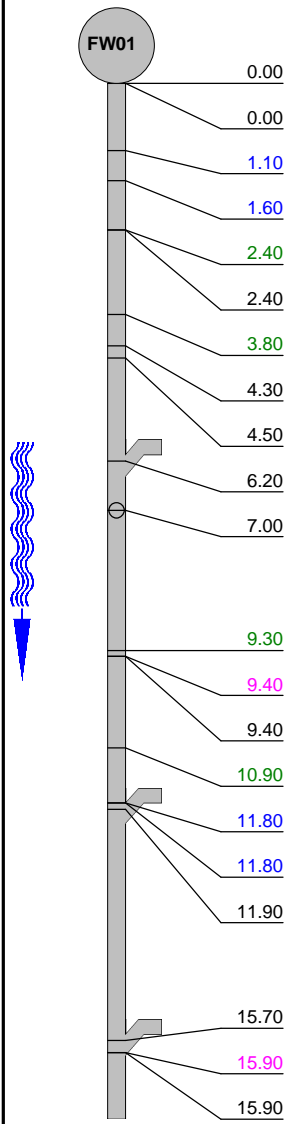
1:124	position	code	observation	grade
Depth: 0.29 / Cover level: 99.58 / Invert level: 99.29 /

0.00	IC	Start node type, inspection chamber, reference number: FW01

0.00	WL	Water level 0 % height/diameter	0
	1.10	CCJ	Crack Circumferential at joint from 04 to 11 o'clock	2
	1.60	CC	Crack Circumferential from 07 to 04 o'clock	2

2.40	OJM	Open joint medium	1
	2.40	GP	General Condition photograph	0
	3.80	DES	Settled deposits fine 5 % cross-sectional area loss	1
	4.30	LR	Line of drain/sewer deviates right

4.50	LL	Line of drain/sewer deviates left	
	6.20	JN	Junction at 09 o'clock dia 100 mm	0
	7.00	CN	Connection at 11 o'clock, dia 100 mm	0
	9.30	S1 DES	Settled deposits fine 10 % cross-sectional area loss, Start	1

9.40	BJ	Broken Pipe at joint from 09 to 01 o'clock	4
	9.40	GP	General Condition photograph	0
	10.90	F1 DES	Settled deposits fine 15 % cross-sectional area loss, Finish	1

11.80	CL	Crack Longitudinal at 10 o'clock	2
	11.80	CL	Crack Longitudinal at 12 o'clock	2
	11.90	JN	Junction at 09 o'clock dia 100 mm	0
	15.70	JN	Junction at 09 o'clock dia 100 mm	0

15.90	H	Hole in sewer from 10 to 12 o'clock	4
	15.90	GP	General Condition photograph	0
